Clinical  
Case Studies

# Puros<sup>®</sup> Allograft Customized Block

## Case 1\*

Failed implant removed and grafted with Puros Custom Block. Six-month re-entry and implant placement

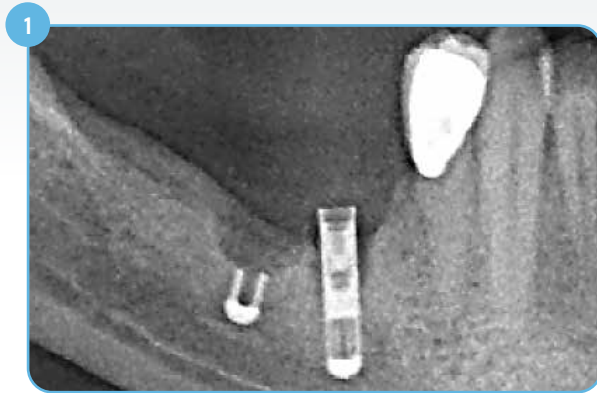
1 Initial situation: More than 50% of implant length exposed due to bone loss; failed implants need to be removed.

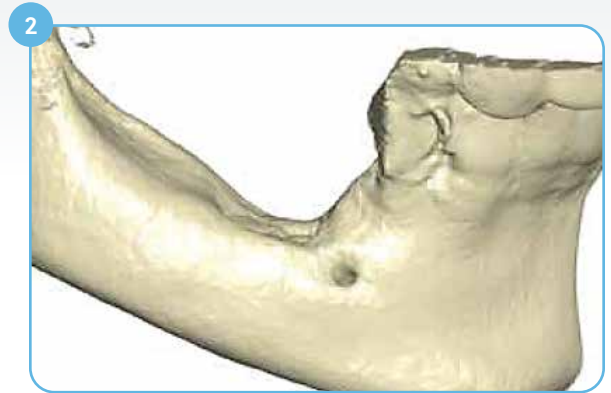
2 Three-dimensional reconstruction of the defect, lateral view.

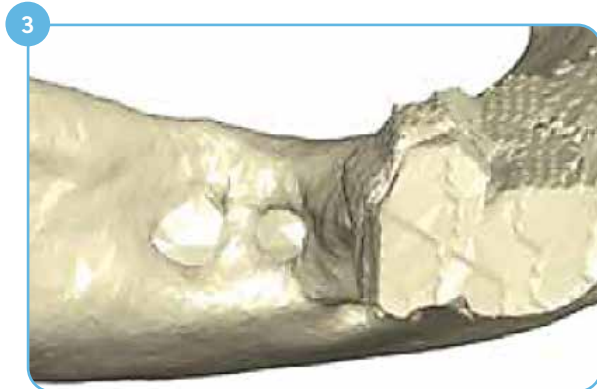
3 Three-dimensional reconstruction of the defect, occlusal view.

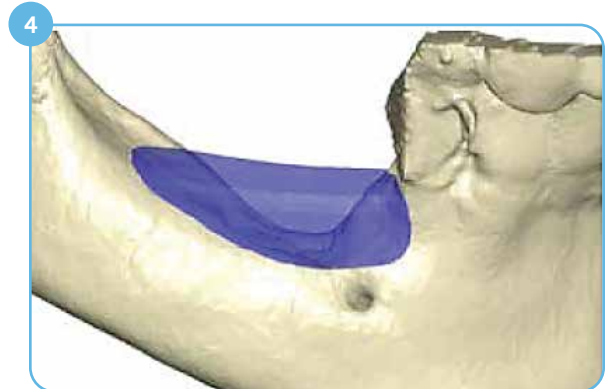
4 Designed bone block, lateral view.

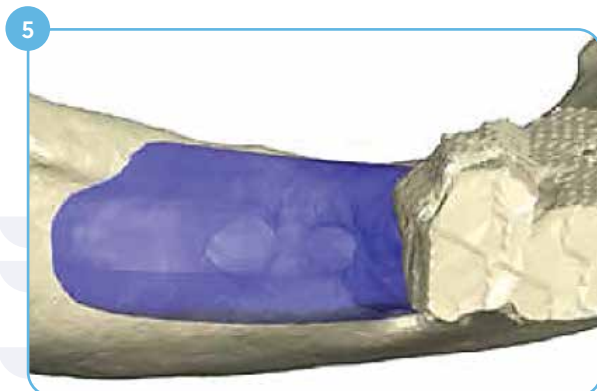
5 Designed bone block, occlusal view.

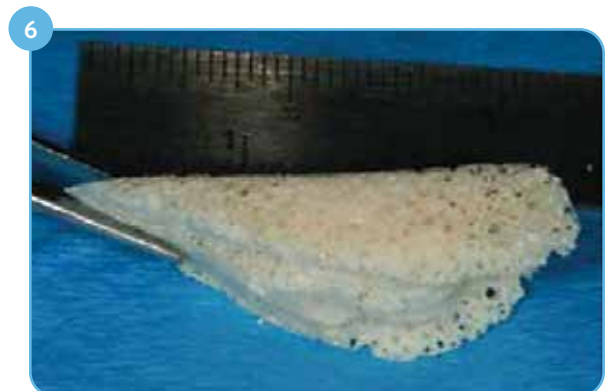
6 Milled Puros Allograft Customized Block.

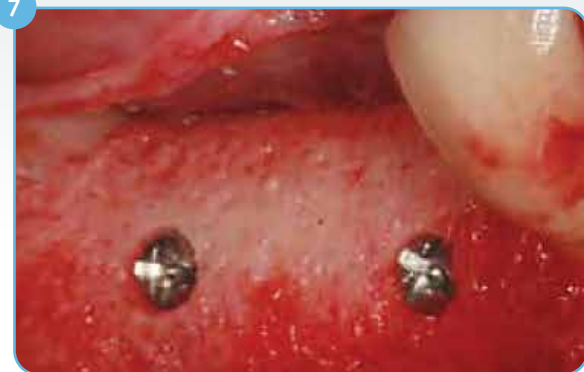
Fixed bone block placed; Screw heads in tight contact with bone.

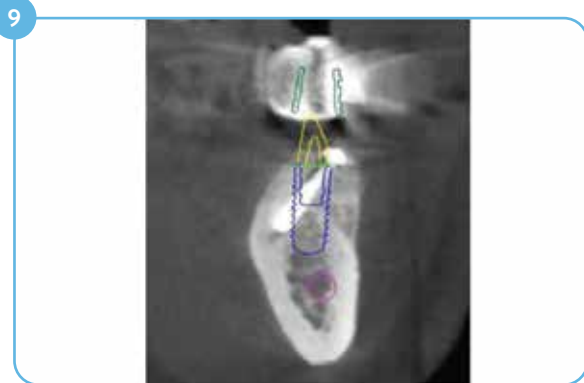
3D diagnostics and implant planning, 6 months post-op.

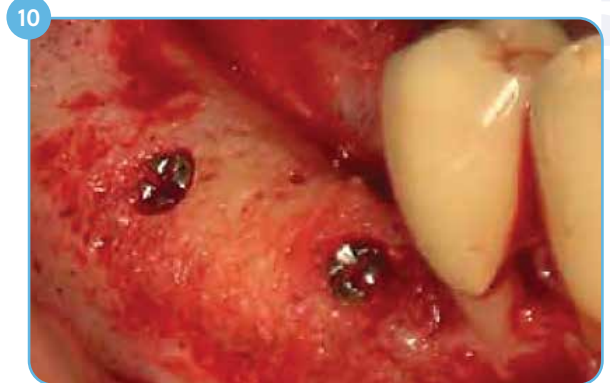
Re-entry 6 months post-op, screws are in tight contact with bone.

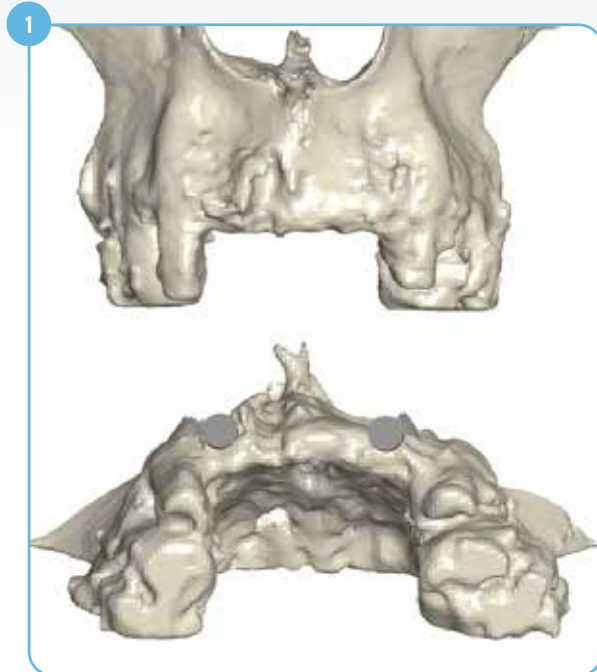
Failed site after autologous grafting; Horizontal augmentation needed; Two 4 mm Ø cylindrical implant placed for reference.

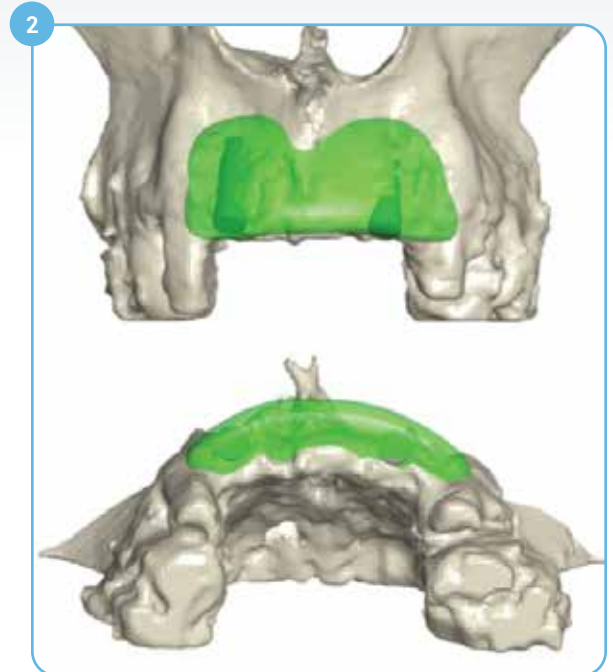
Green object represents the designed custom block.

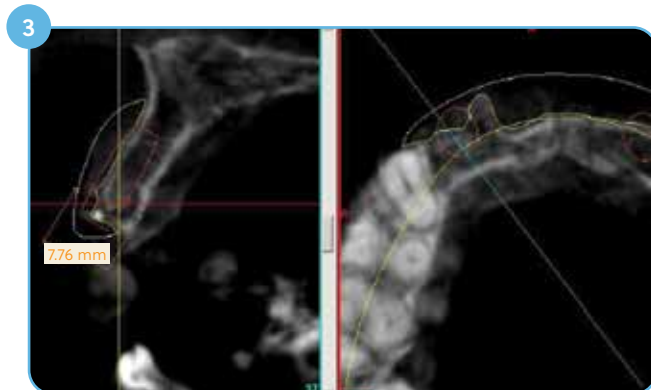
Cross section at tooth position #7 (maxillary lateral incisor); Yellow contour represents the designed custom block.

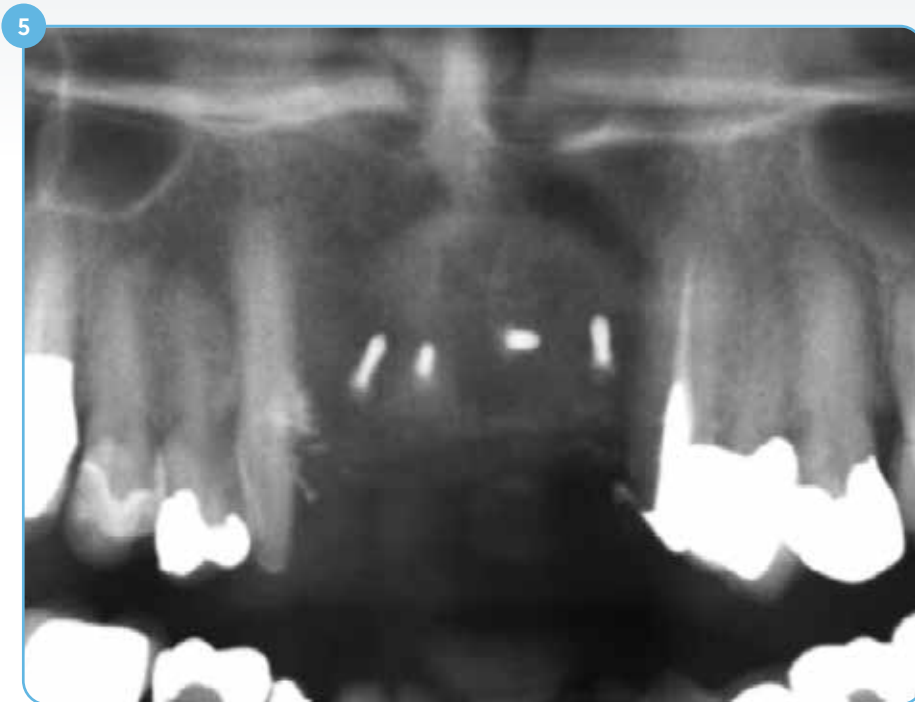
Post-grafting radiograph; block fixed with four screws.

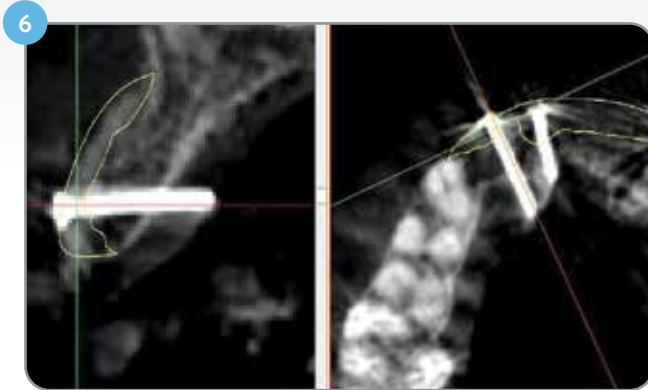
Five months post-grafting CBCT-scan superimposed with designed block (yellow contour). Tooth position #7 (maxillary lateral incisor).

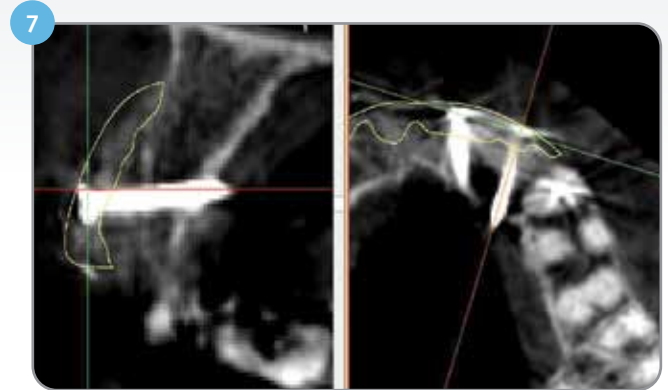
Five months post-grafting CBCT-scan superimposed with designed block (yellow contour) shows stable bone volume after five months. Tooth position #10 (maxillary lateral incisor).

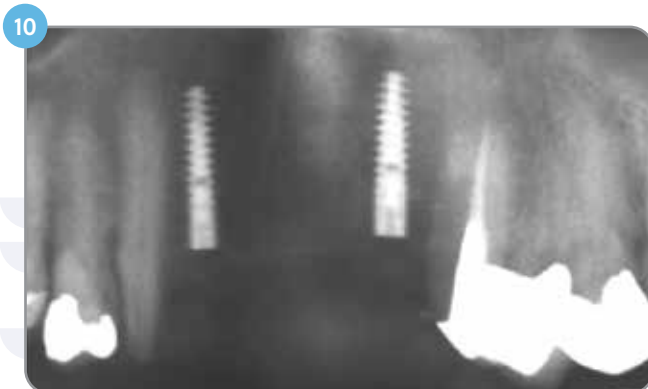
Five months after grafting: Two implants have been placed in tooth position #7 (maxillary lateral incisor) and tooth position #10 (maxillary lateral incisor).

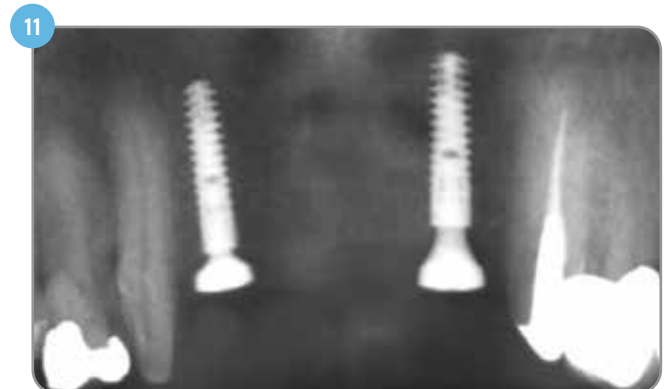
Radiograph after uncovering of the implants three months after implant placement; bone level maintained up to crest of implant.

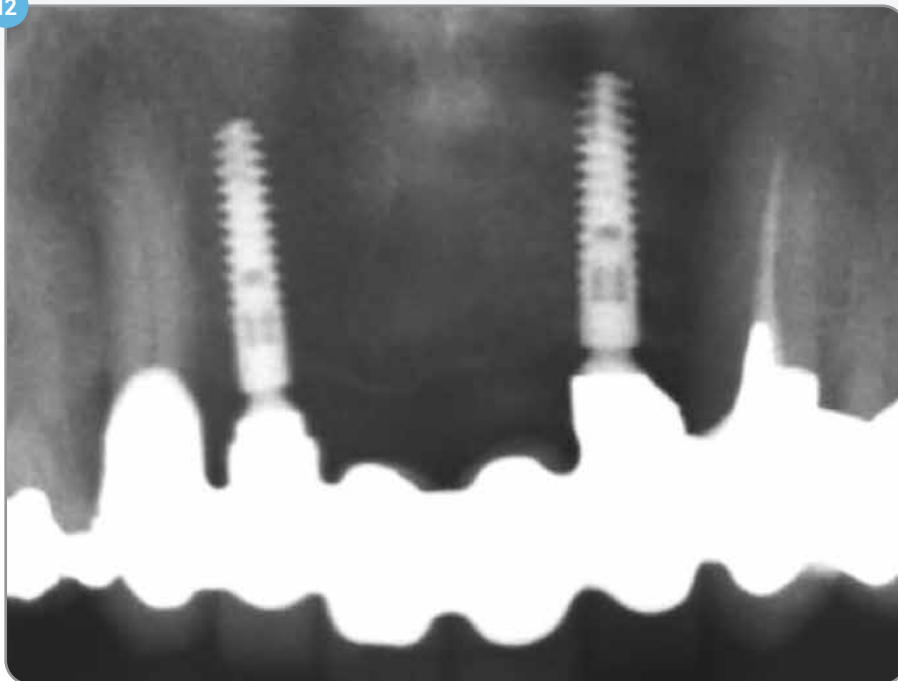
Radiograph two years after implant loading. Stable bony levels at implant shoulders (both mesial and distal).

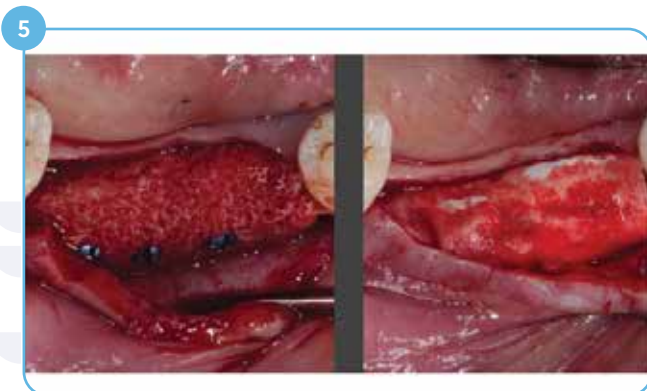
5 Custom block fixed with three screws.

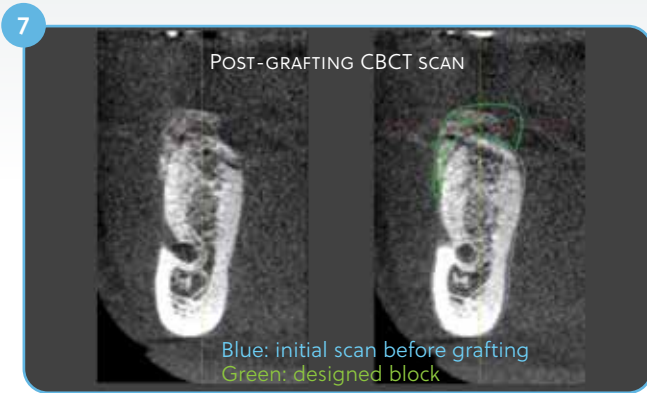
Post-grafting CBCT scan good fit, deviation lingually. Tooth position #29 (mandibular second pre-molar).

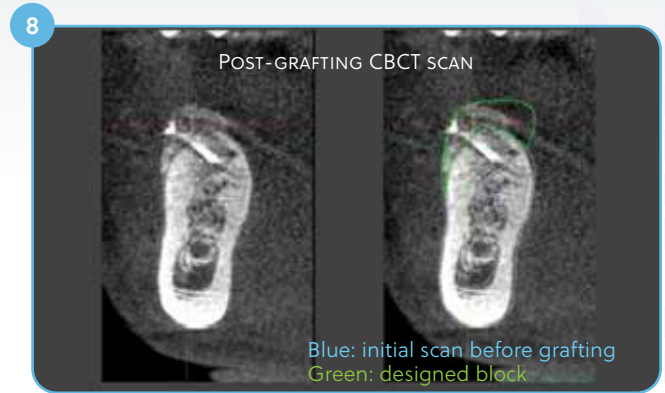
Post-grafting CBCT scan good fit, deviation lingually. Tooth position #30 (mandibular first molar).

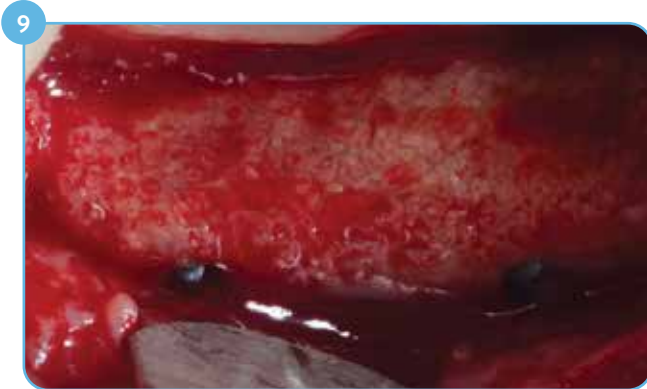
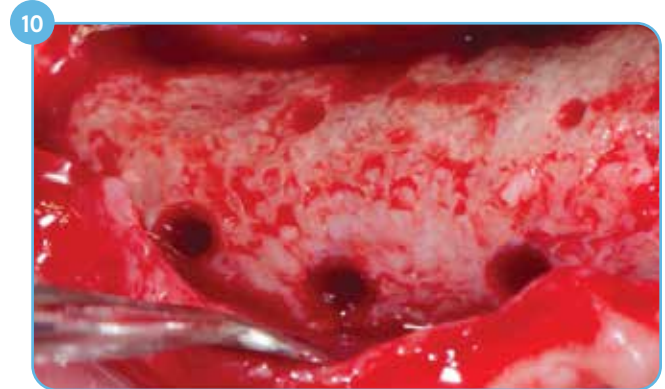
Uneventful healing; no resorption - head of the screw is in complete contact with bone.

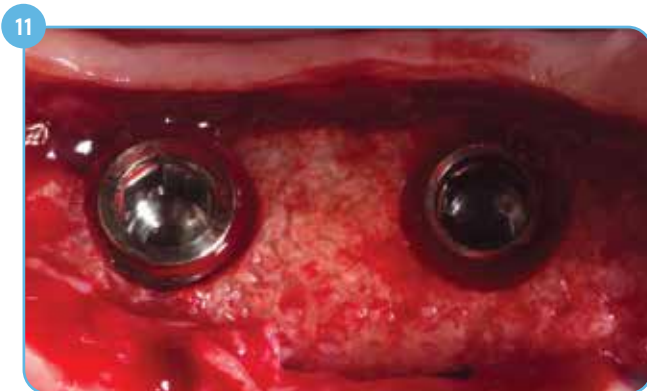
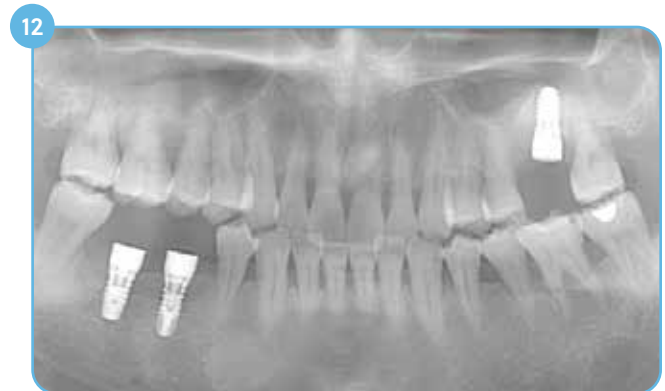
Cancellous structure of the custom block covered with a thin layer of cortical bone.

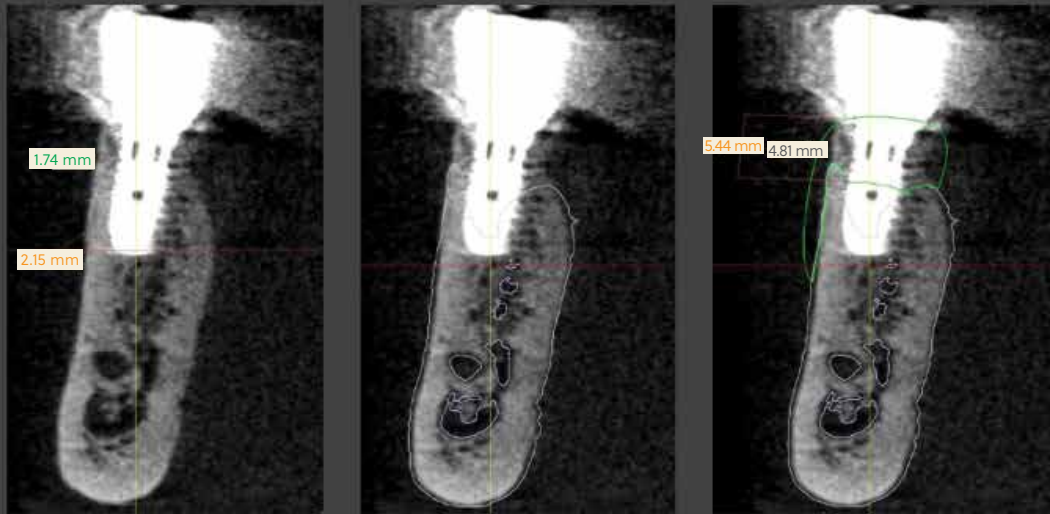
4.5y follow-up CBCT scan

4.5y follow up CBCT scan  
Blue: initial scan before grafting  
Green: designed block

Four-and-a-half-year follow-up CBCT scan shows vertical gain of 4.8 mm (vs. 5.4 mm planned), thick buccal plate 1.74 – 2.19 mm). Tooth position #29 (mandibular second pre-molar).

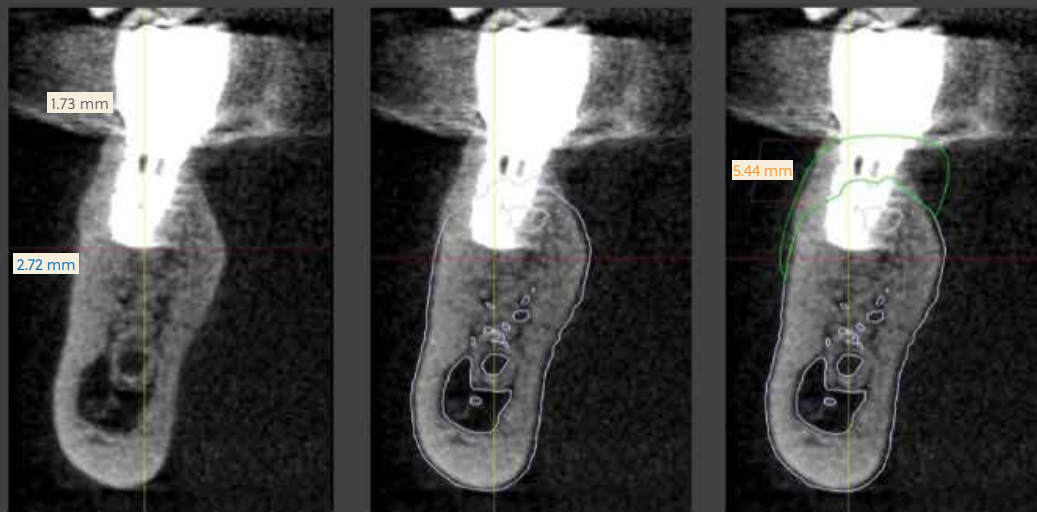
4.5y follow up CBCT scan  
Blue: initial scan before grafting  
Green: designed block

Four-and-a-half-year follow-up CBCT scan shows vertical gain of 5.32 mm (planned), thick buccal plate (1.73 – 2.72 mm). Tooth position #30 (mandibular first molar).

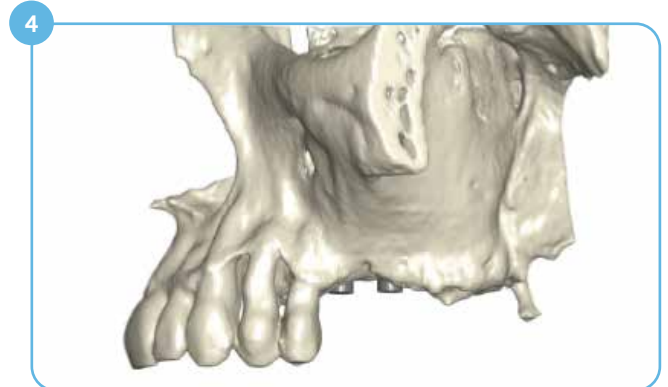
4 Lateral view: Two implants (4.3x11 mm) have been placed in the 3D model for reference; implant shoulders requiring bone augmentation.

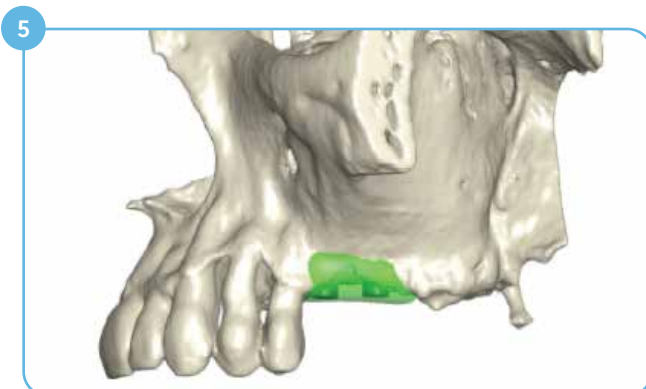
5 A bone block has been designed to reconstruct deficient sinus floor at tooth position #14 and #15.

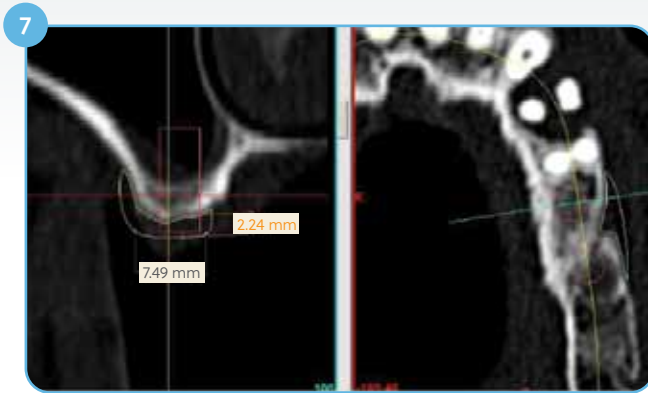
Cross section at tooth position #14 (maxillary first molar); yellow contour of the designed block fits nicely over the original scan.

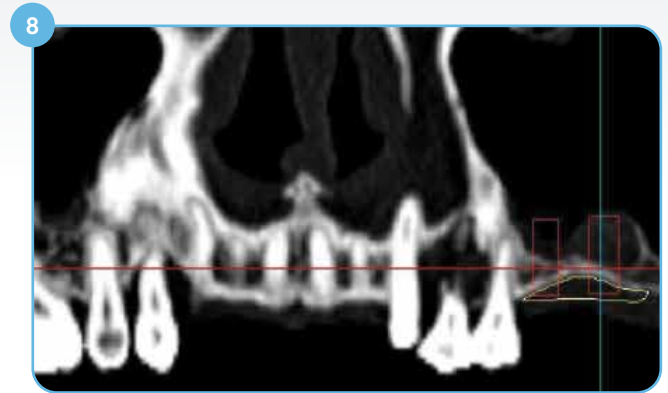
Baseline CT scan superimposed with implants (red) and designed bone block (yellow).

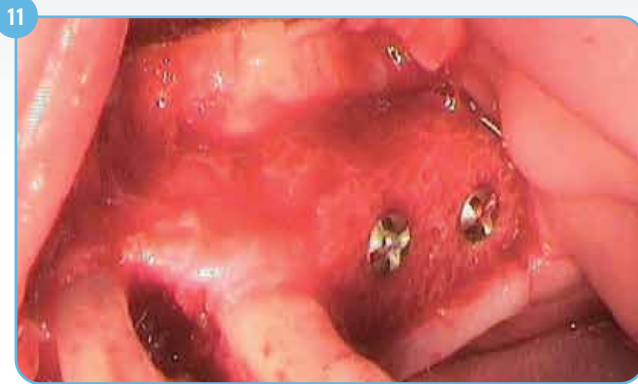
11 Puros Allograft Customized Block fixed with two fixation screws.

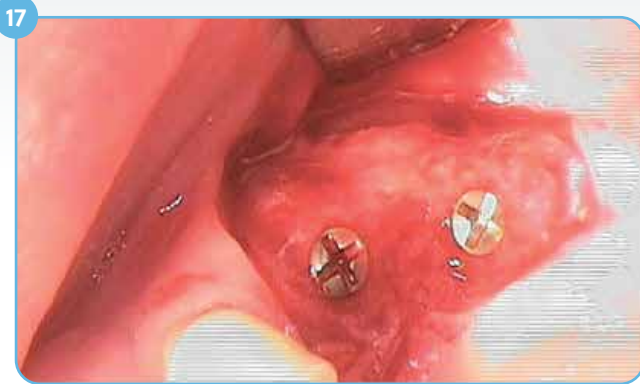
17 Clinical situation six months post-grafting during re-entry, well integrated bone block with minimal signs of resorption.

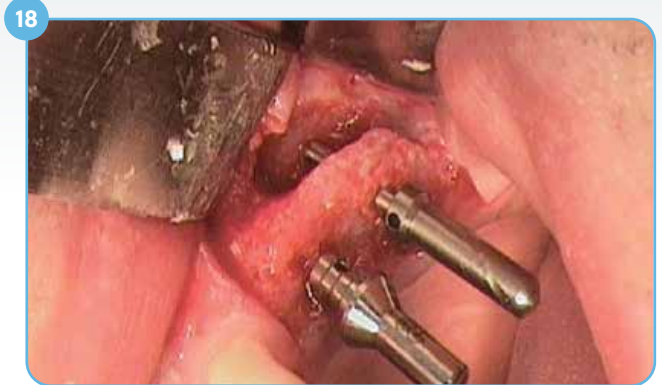
18 Two T3® Implants 4x11.5 mm have been placed with simultaneous sinus grafting using autogenous bone; sufficient sinus floor thickness achieved for implant placement.

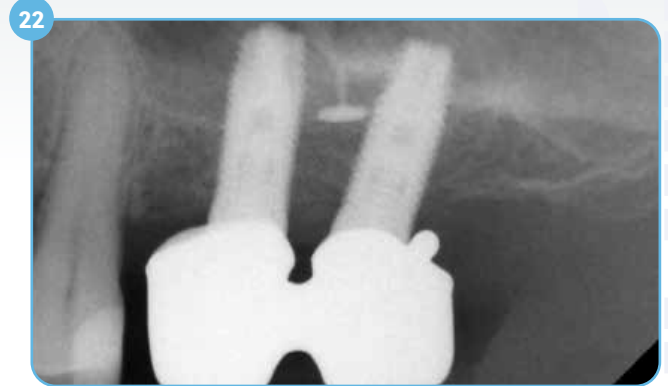
Two-year follow-up radiograph; implant in stable condition.

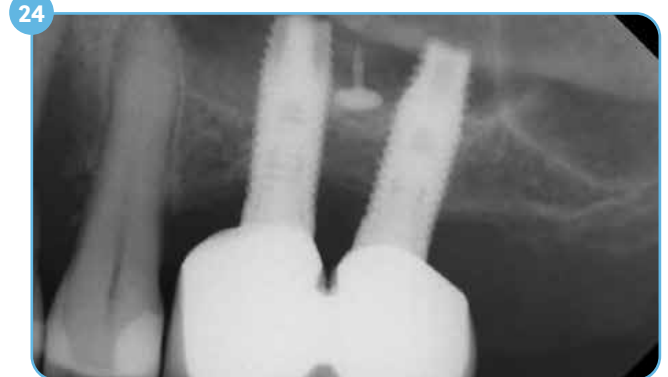
Four-year follow-up radiograph; implant in stable condition.
